Report on Installation Activities at the LWDA Site

John Copeland, Aaron Kerkhoff, Charlie Slack, Johnathan York

This brief report offers a summary of the Long Wavelength Demonstrator Array (LWDA) installation activities that occurred during the week of June 19-23, 2006. We will focus on briefly identifying what was accomplished, what remains to be done, and then some interesting points to guide future efforts at the site.

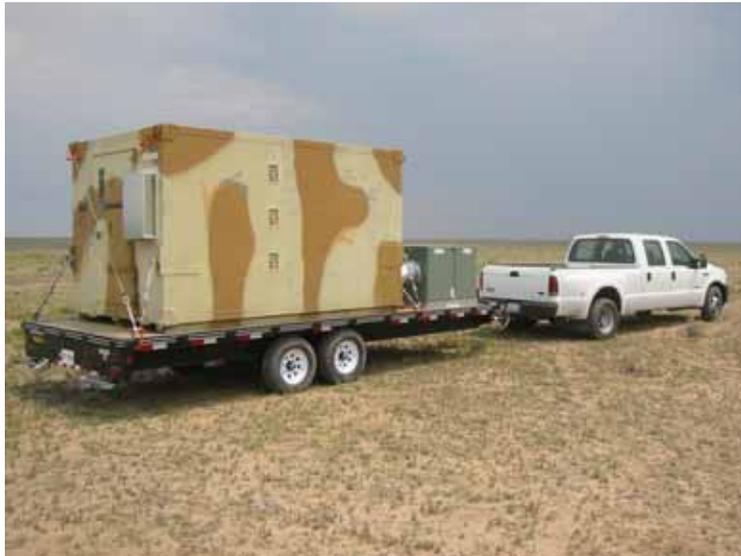
On entering the site, there was a point at which the truck pulling the trailer became temporarily stuck in the sand near the site. Assistance from NRAO personnel helped get the vehicle moving again, and there were no further problems.

Figure 1. Shelter arriving at the LWDA site. AC unit is at the front of the trailer.

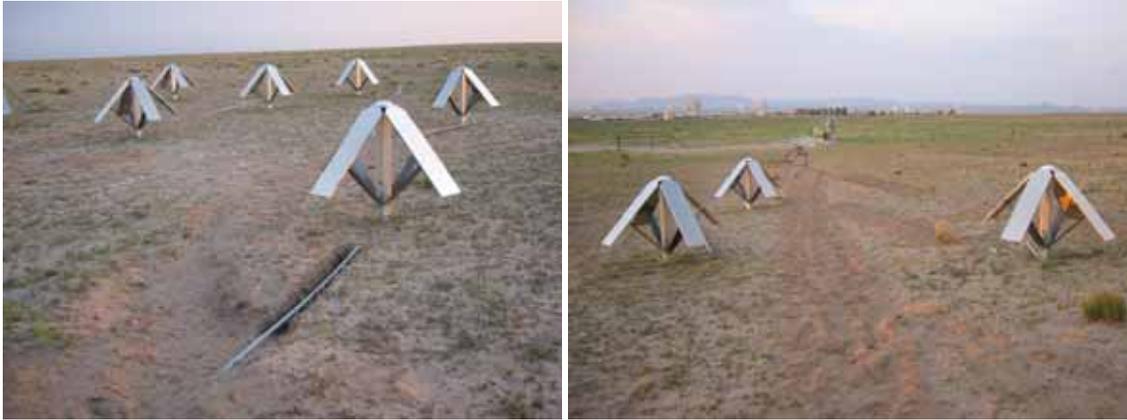
Figure 2. Photos showing the array and conduit runs that were previously installed.

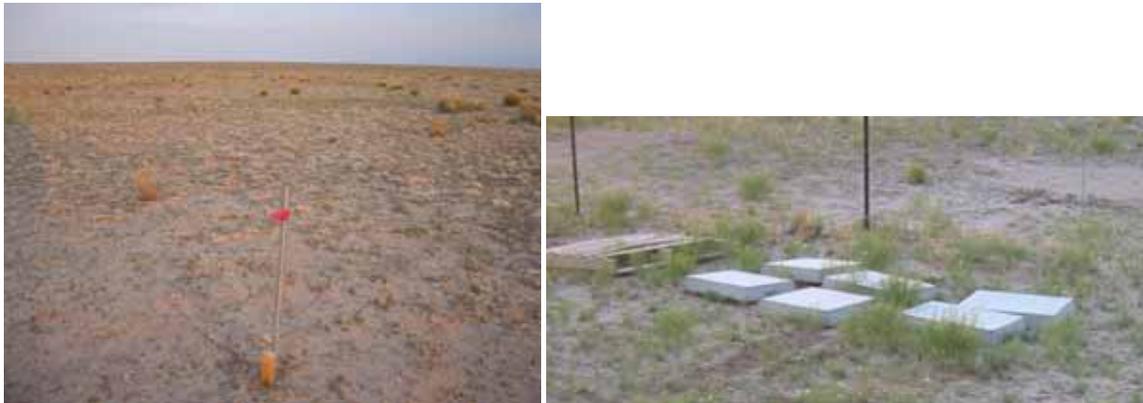
Figure 3. Photo showing center of array marker on the left, and foundation blocks on the right.

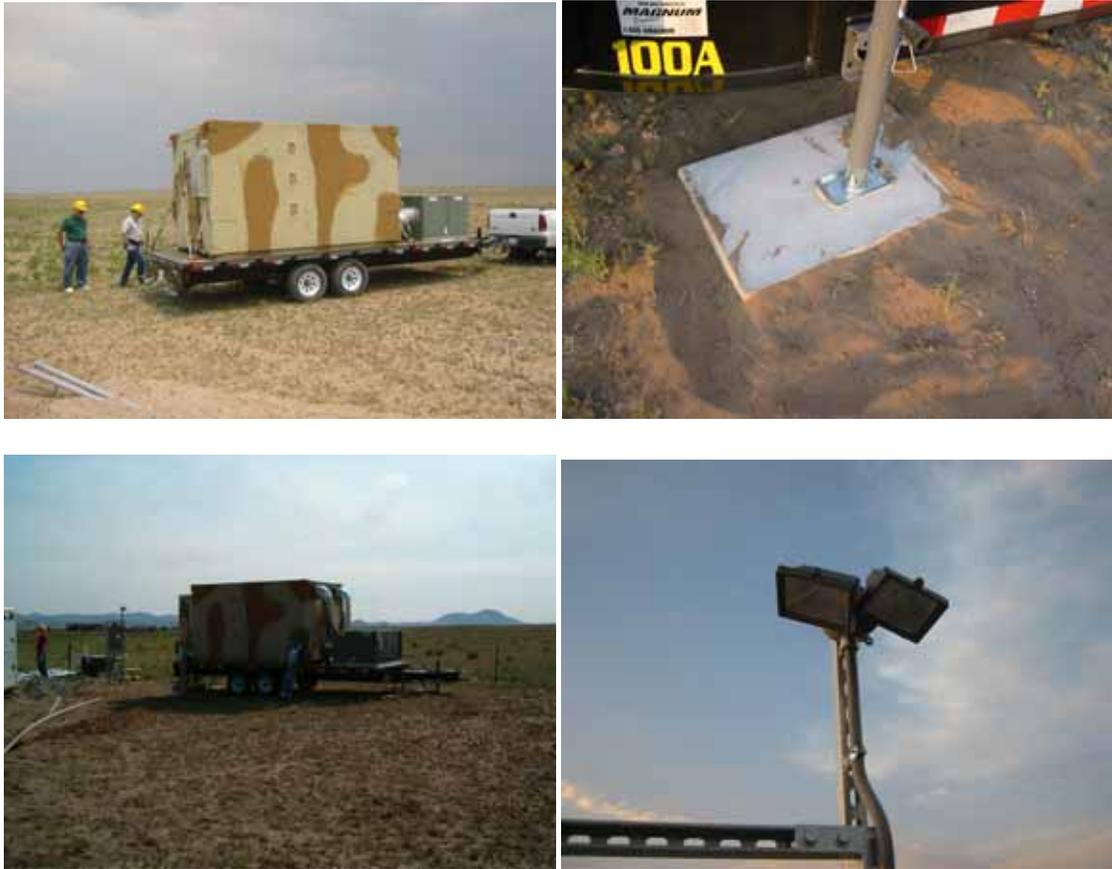
We installed the shelter at the site, mounting it on four of the five provided jacks and seated on four of the concrete pads procured and left at the site by Walter Gerstle of UNM. The fifth jack is the tongue jack, positioned in the triangular portion of the trailer frame. This jack was not used because it is close to two of the other jacks, and it is difficult to maintain an even weight distribution across all three.

Figure 4. Photos of the shelter installation. Clockwise from top: positioning the shelter, concrete pad for the shelter jacks, the lights illuminating front of the shelter, and the final shelter location with the junction box at right.

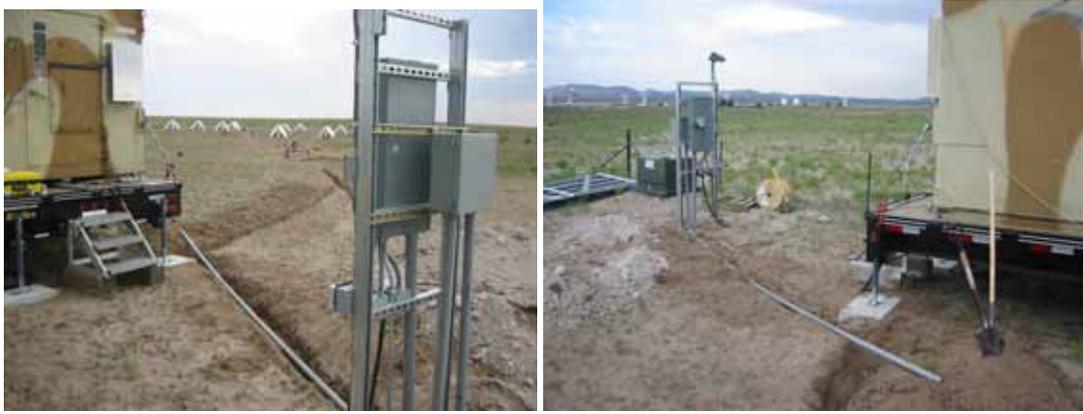
The fiber patch cord running from the shelter to the junction box was installed. NRAO had replaced the junction box previously installed with a better junction box. This box had a penetration cut in it which was too large for the conduit NRAO uses, but which worked for the LWDA conduit.

The NRAO fiber in the box was not terminated in connectors, and so could not be connected to the LWDA patch cord. As it turned out, further testing of this link by NRAO staff indicated a problem on the line that they installed. On Friday, NRAO staff were continuing to troubleshoot the problem.

Figure 5. Photos showing the installation of the fiber conduit from junction box to shelter.

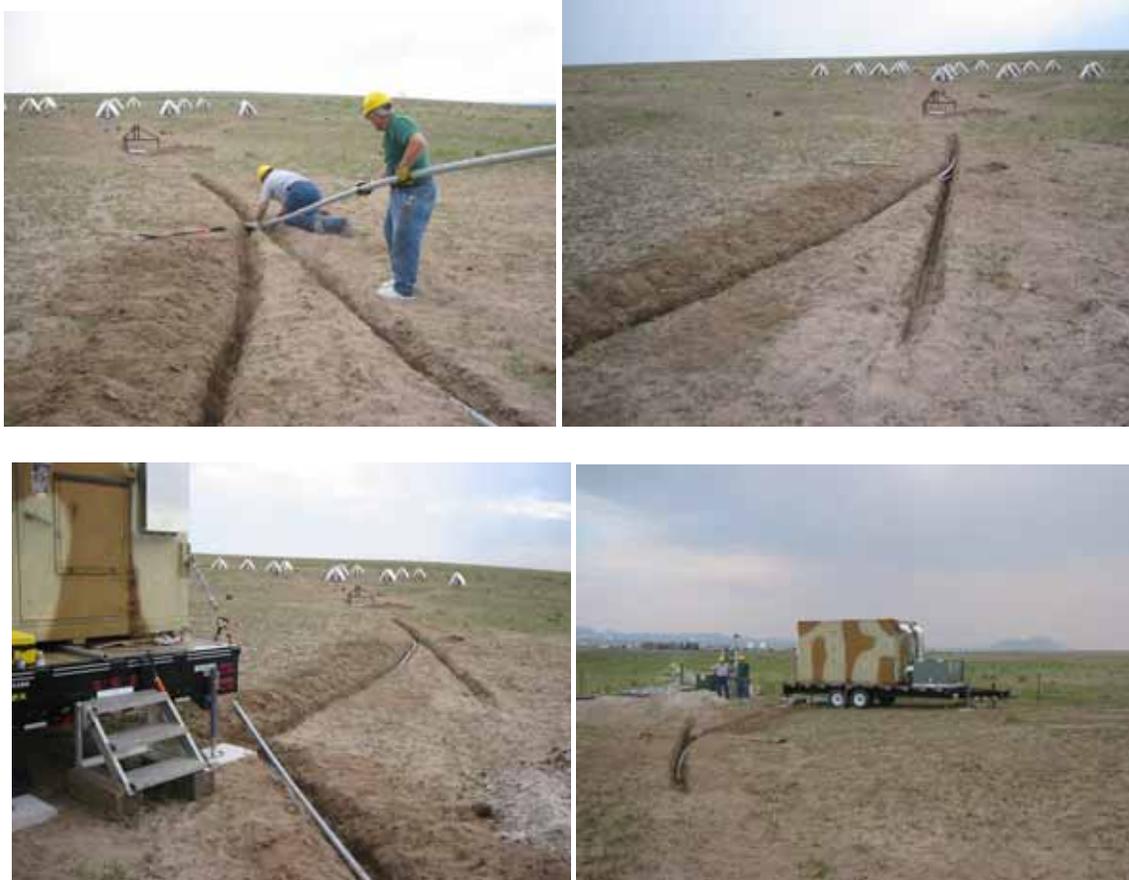
1. A slightly different location of the shelter was used than originally indicated in site drawings that were provided to UNM.
2. The conduits that had been installed did not penetrate the collector box at right angles to the sides, making the sealing of the penetrations against water difficult.

Figure 6. Photos showing the relocation of the two 2" conduit lines from the collector box at the array edge to fit the actual shelter location.

Revisions to the conduit took a considerable part of the week, and this suggests that in the future more detailed drawings and planning are required for this work. Conduit runs were completed for all antennas and the incoming fiber.

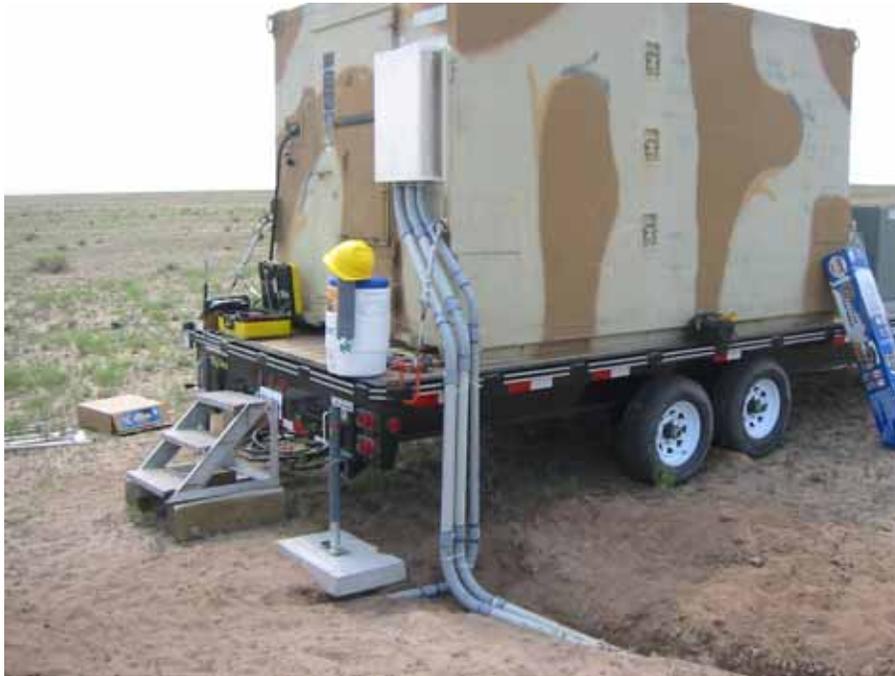
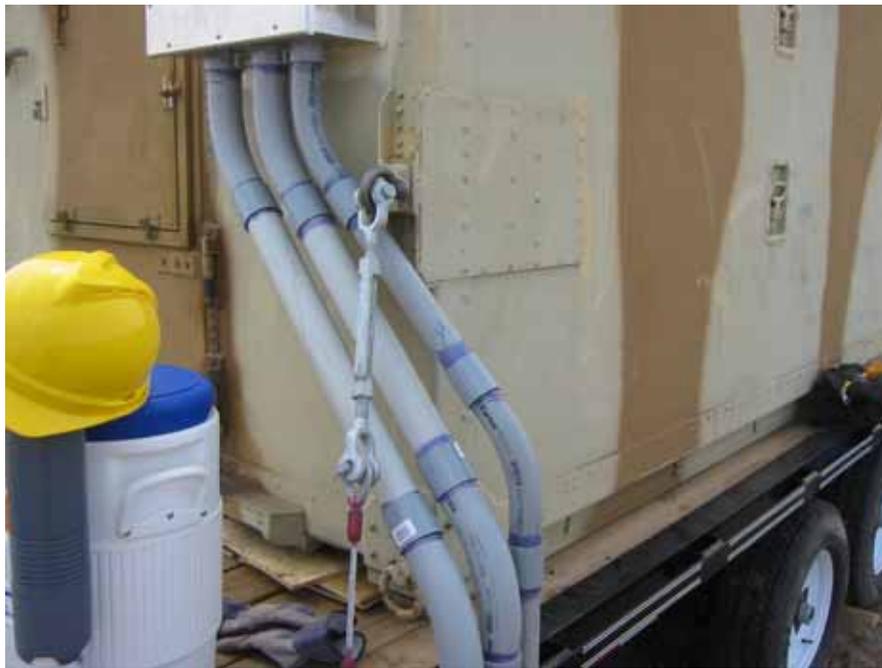
We attempted, but failed, to install the trailer tie-down hardware which would anchor the shelter in a serious wind storm. It was not possible to drive the large anchoring screws into the ground with the manual equipment available. We may want to investigate having a contractor take care of this for us (a contractor with the requisite power tools!).

Figure 7. Top photo shows completed antenna and fiber conduit running to shelter patch panel. Bottom photo shows detail of the conduit meeting the patch panel, as well as one of the shelter tie-downs.

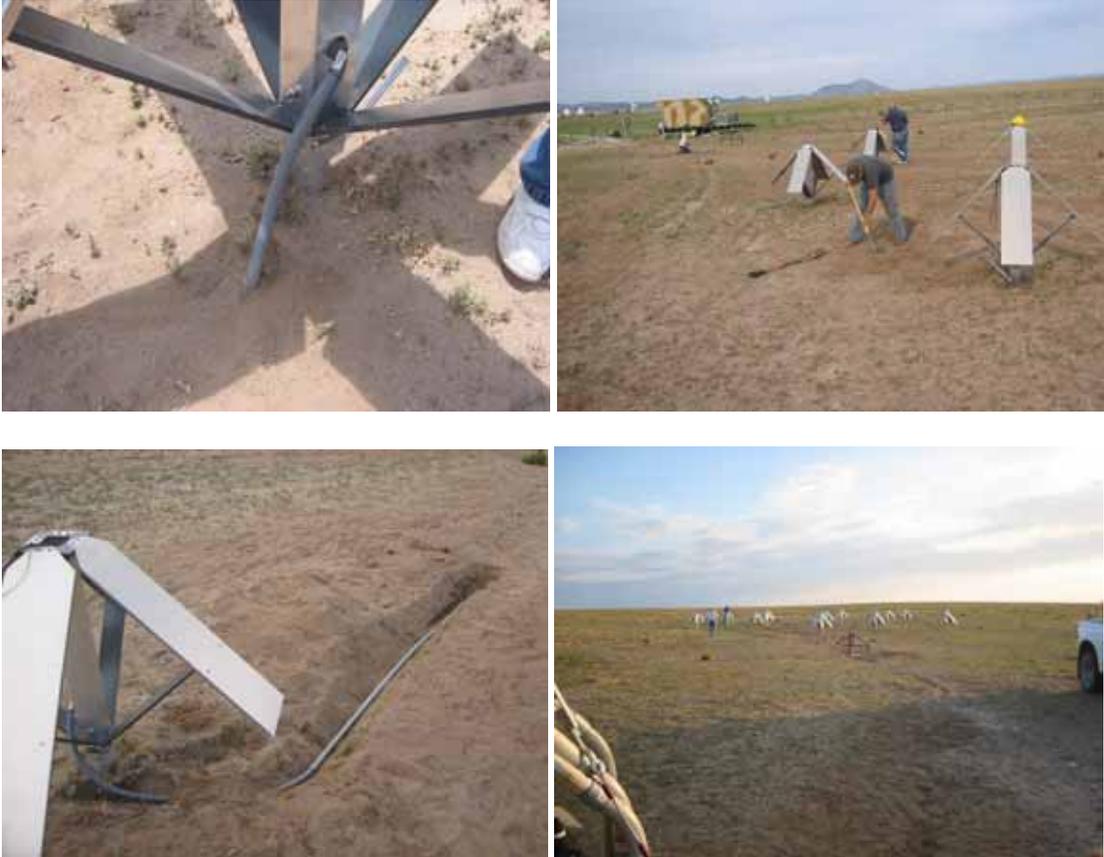
Figure 8. Clockwise from top left: 1) flexible conduit attached to antenna mast, 2) trenching for the final connection to the antennas, 3) looking out from the shelter to the completed (but filled) runs, and 4) a completed, unburied section, of the flexible conduit running to an antenna

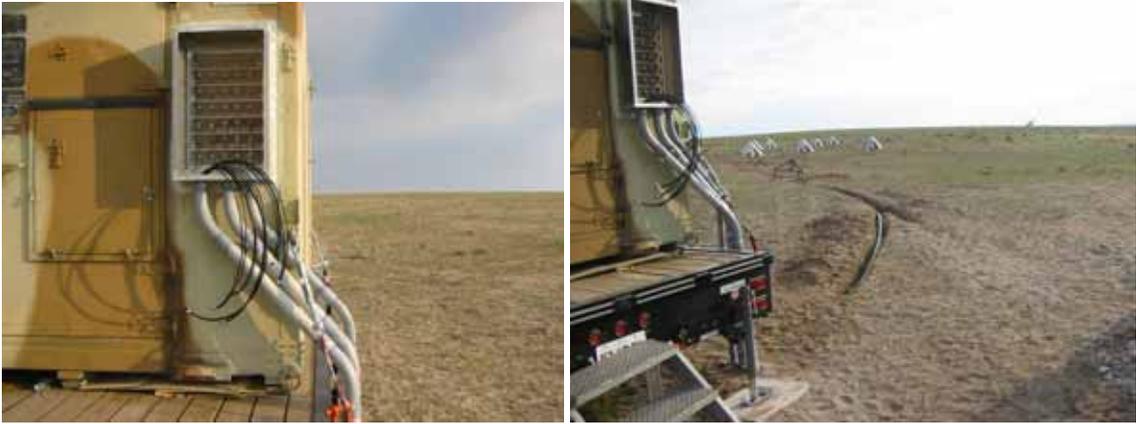
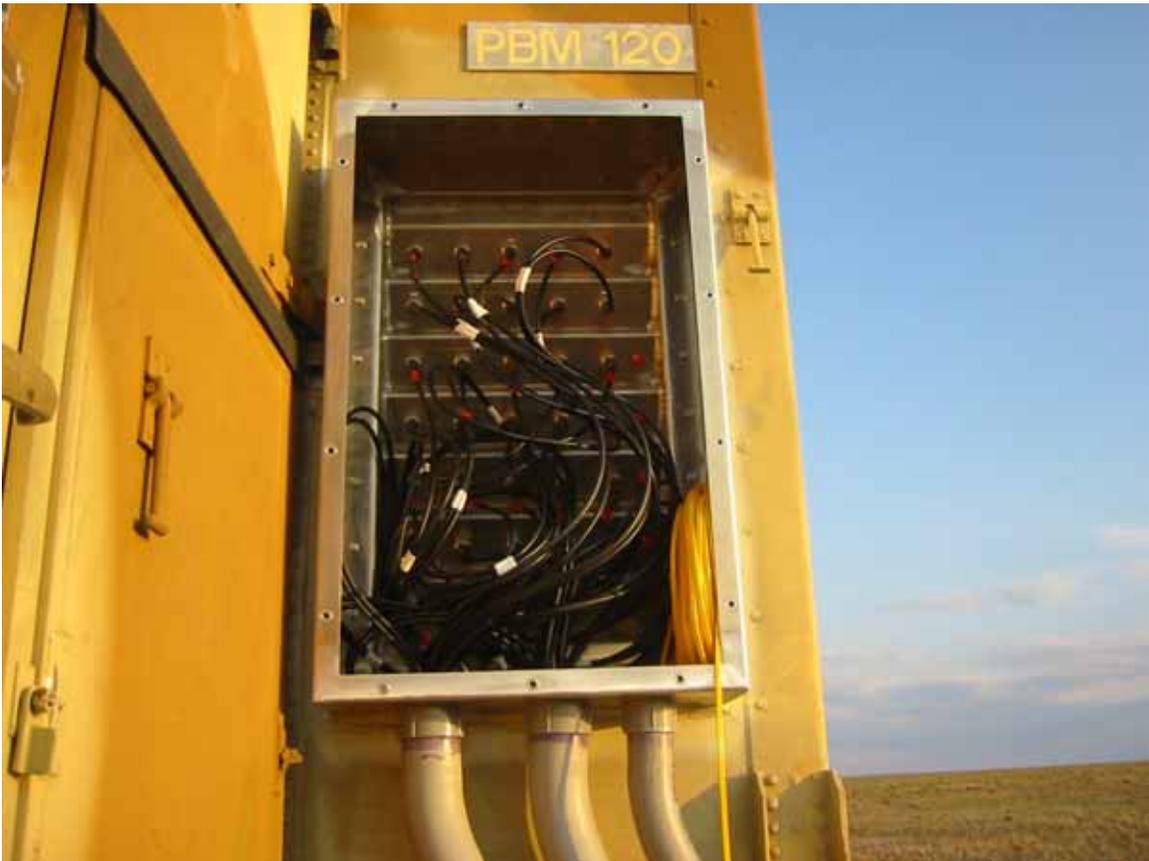
Figure 9. Photos of the incoming antenna cables at the shelter. Fiber is the yellow cable on the right of the bottom photo.

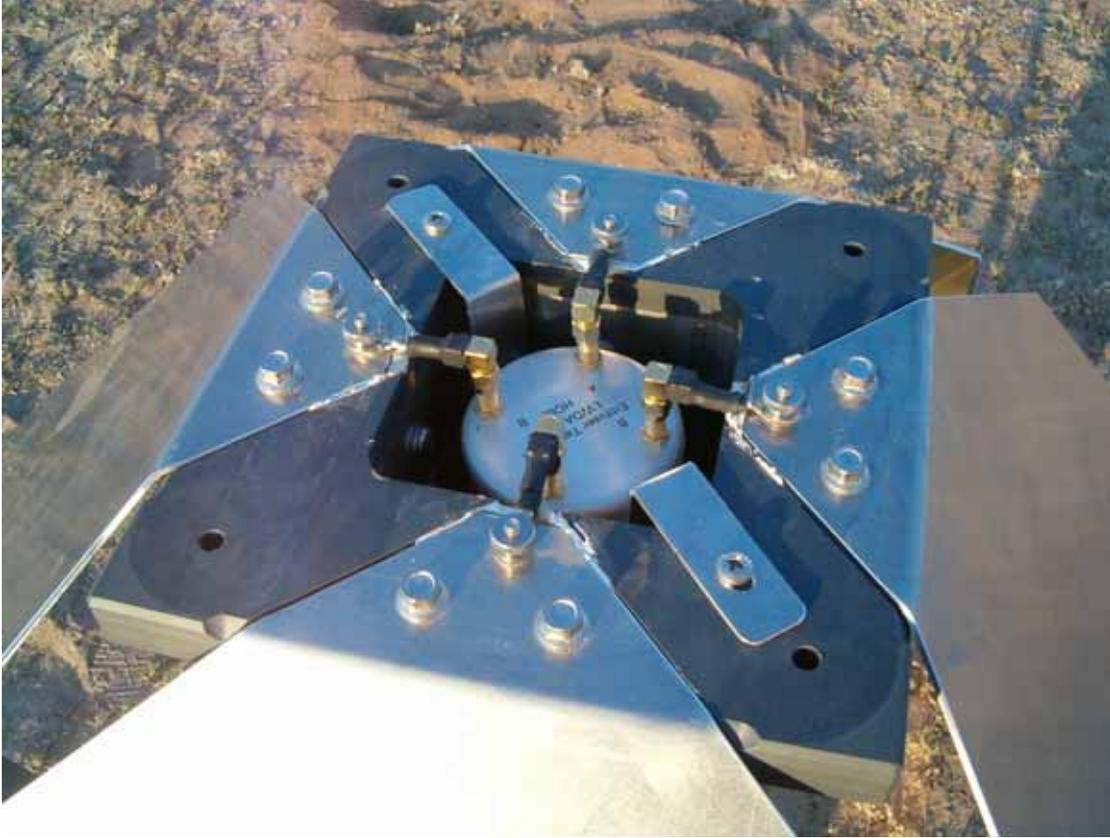
Figure 10. Photo showing an installed balun.
