Testing a Prototype Blade Antenna at the LWDA-1 Site

Nagini Paravastu, William Erickson, Ylva Pihlstrom, Namir Kassim
August 30, 2005 – September 1, 2005

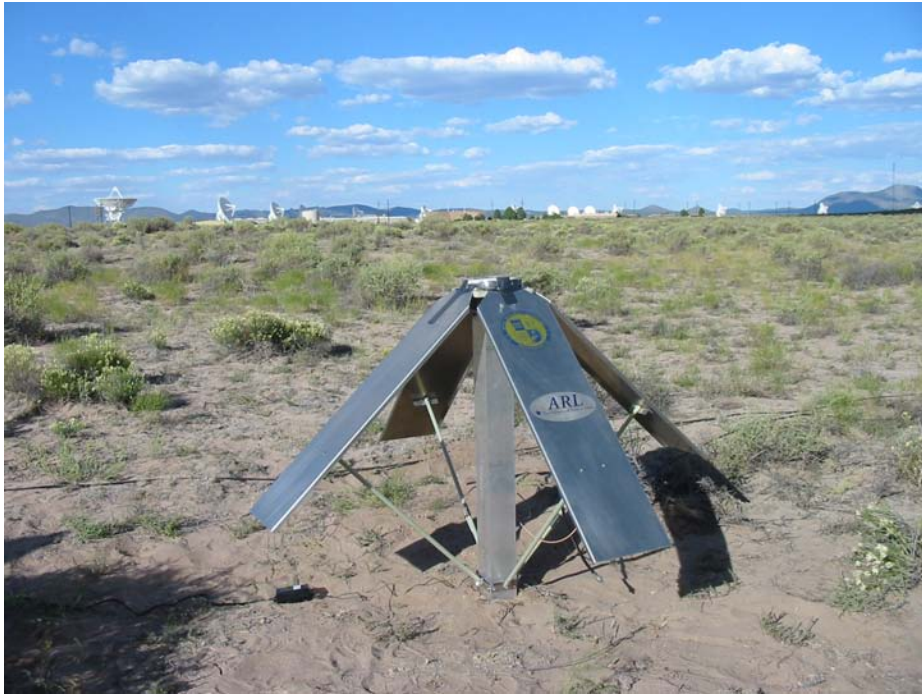
Fig. 1. Prototype blade antenna at the LWDA-1 site.

A photograph of the fully assembled blade antenna is shown in figure 1. The Hicks balun, mounted inside the antenna mast, is shown in figure 2.

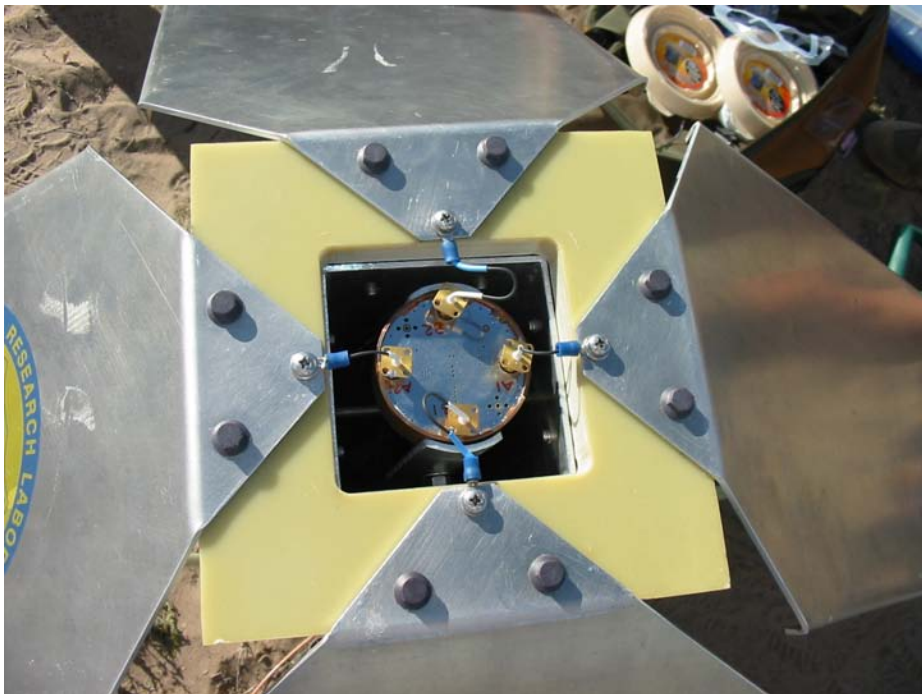
Fig. 2. Hicks balun mounted in mast of prototype blade antenna.

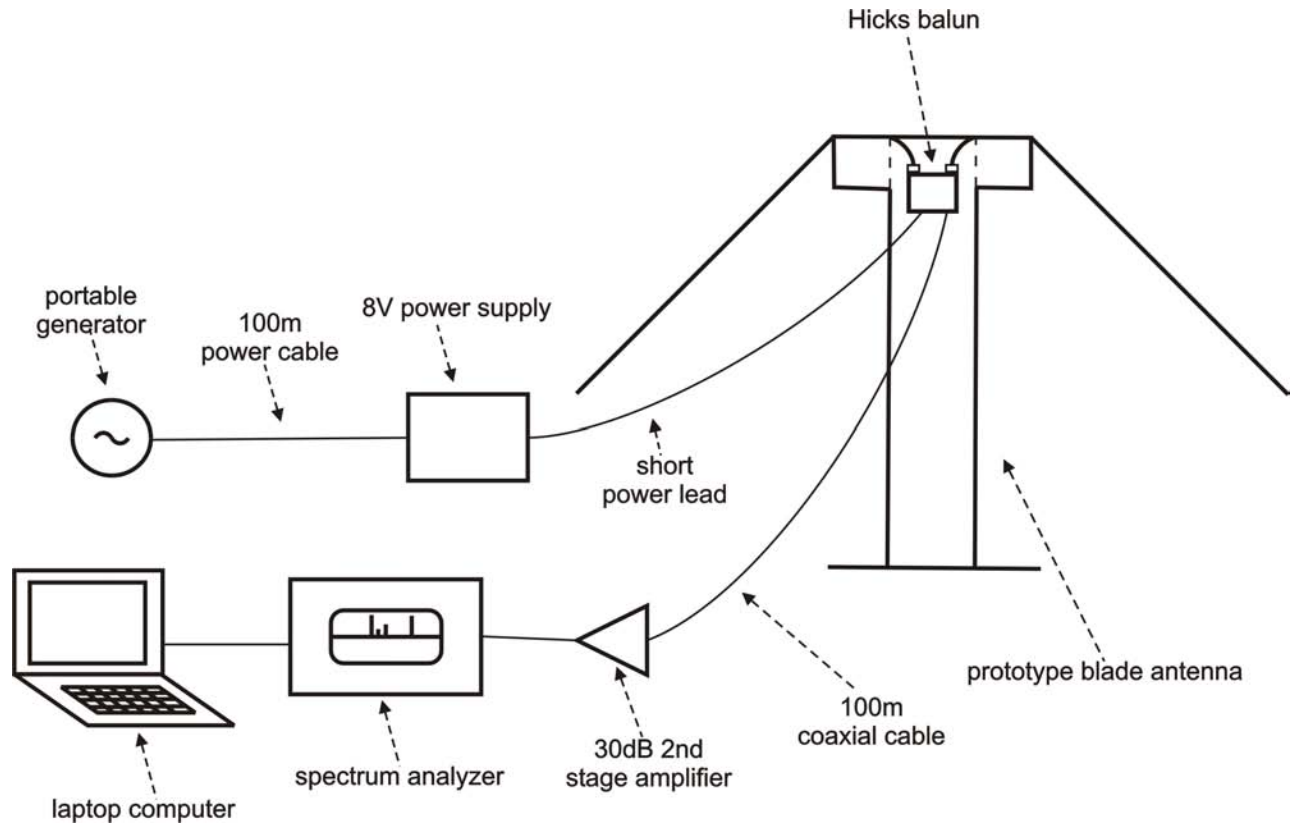
Fig. 3. Measurement system used in testing blade antenna at the LWDA-1 site.

A diagram of the experimental set-up is shown in figure 3. Signals received by the blade antenna were transmitted through the Hicks balun and a 30 dB second stage amplifier to a spectrum analyzer. The spectra were recorded by a laptop computer that was connected to the spectrum analyzer. This system was used to determine the degree to which sky noise is dominant over the noise power of the balun. These results are presented and compared with simulated predictions in section III.

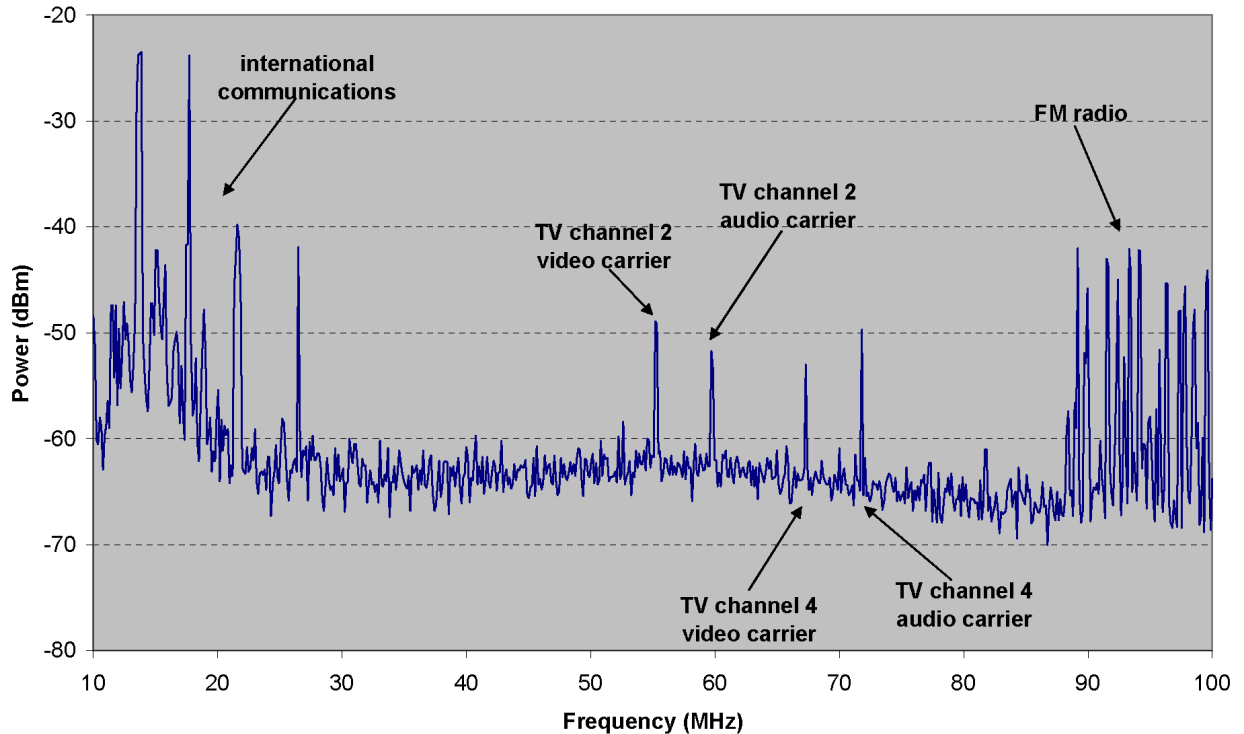
Fig. 4. The first spectrum (from 10 – 100 MHz) recorded at the LWDA-1 site using a blade antenna and a Hicks balun.

Figure 4 shows the first spectrum taken using a 1m blade antenna and the Hicks balun at the LWDA-1 site from 10 – 100 MHz. Subsequent measurements were taken between 40 MHz and 90 MHz since the 1m blade antenna was optimized for use in this frequency range.

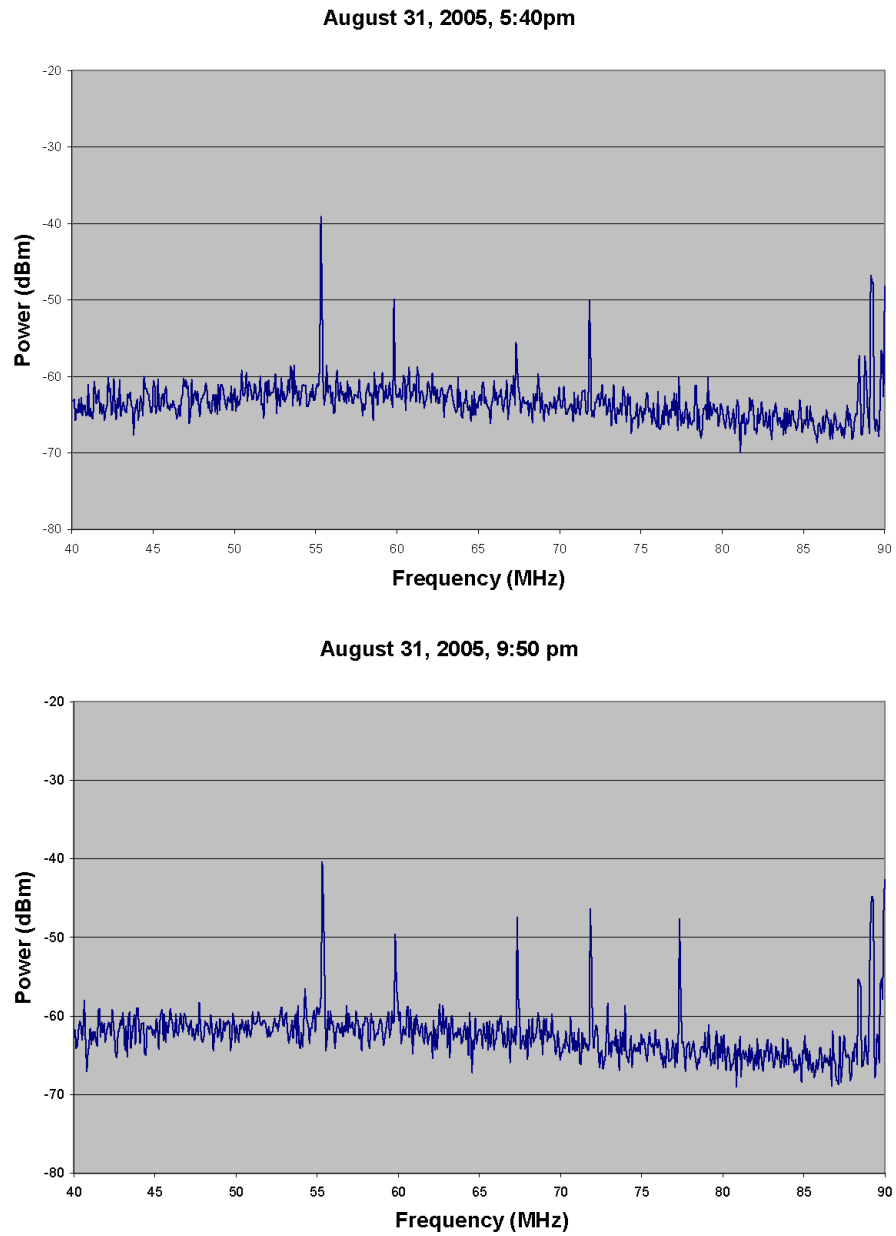
Fig. 5. Two samples of sky noise spectra (from 40 – 90 MHz).

Spectra from 40 – 90 MHz were recorded approximately every 2 hours from the afternoon of Wednesday, August 31st until early morning on Thursday, September 1st. Figure 5 shows samples of two recorded spectra. Variations in the noise floor were observed from measurement to measurement, suggesting that the system is sensitive enough to detect diurnal variations in the sky noise. This would have to be verified, however, with longer-term measurements in the near future. Planning for such measurements at the NRAO facility in Green Bank, WV is already underway.

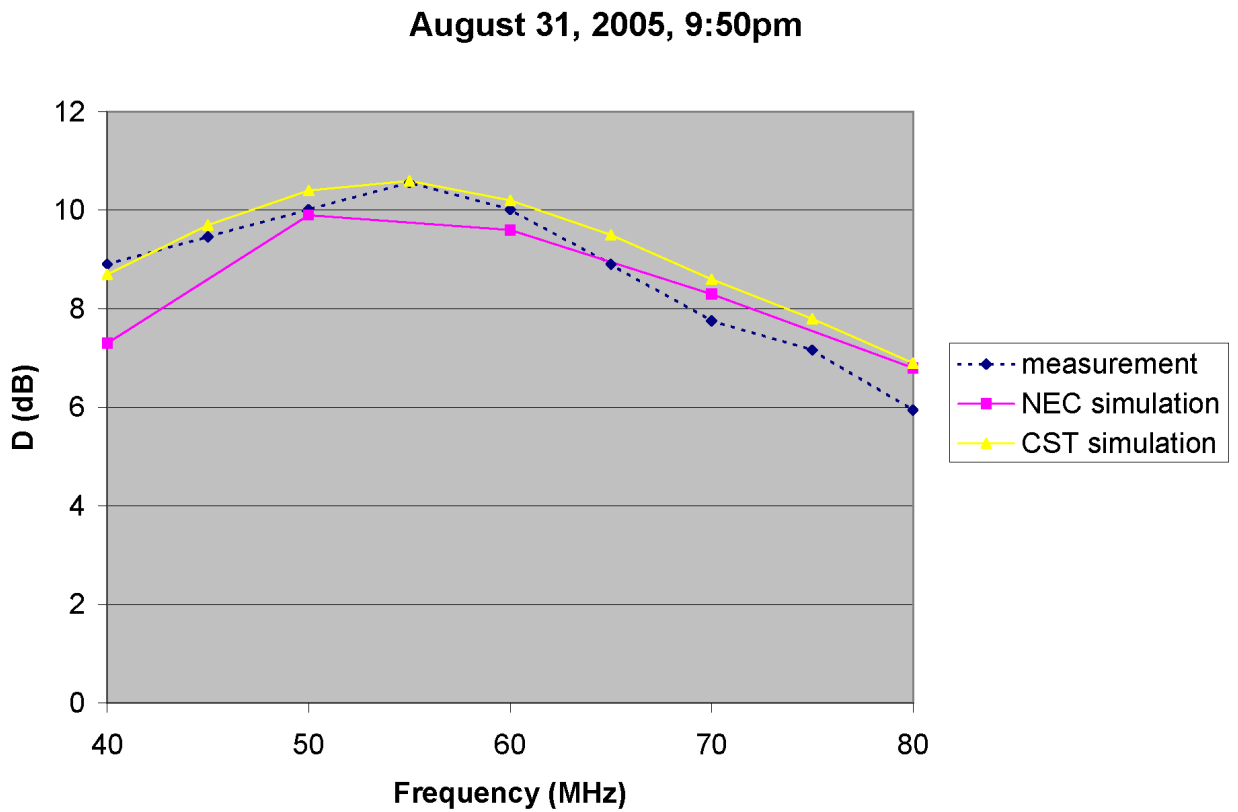
Fig. 6. Sky noise-to-balun noise ratio versus frequency. Both simulations assumed a perfect ground plane under the antennas, whereas the measurements were done on Earth ground. Measurement and simulation shows a minimum of 6 dB sky noise dominance over the entire 40 – 80 MHz range.

Figure 6 compares the results from the August 31st 9:50 pm measurement with simulated predictions from NEC and CST. There is excellent agreement between measurement and simulation. Both show a minimum of 6 dB sky noise dominance over the 40 – 80 MHz range.

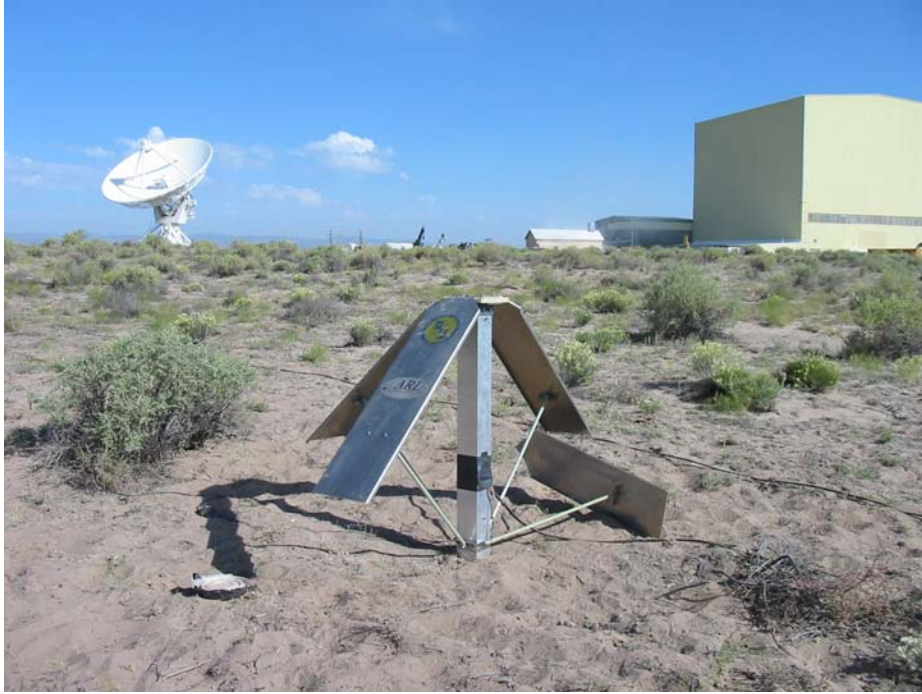
Fig. 7. The damaged blade antenna. One blade was detached from the mast.

Some time between 4:00 am and 6:00 am on September 1st, it was discovered that the blade antenna and the cables had been damaged by animals. As shown in Figures 7, 8, 9, and 10, some fairly large animal broke one of the blades off the antenna. There were no cattle tracks in the area, but some antelope tracks. Other animals, probably rabbits, rats, or gophers had gnawed the cables and, in particular, had broken the 8V power lead to the balun. For future work it will be necessary to protect all antennas with a fence, presumably a field fence topped with several strands of barbed wire, and to protect all wires and cables with conduit.

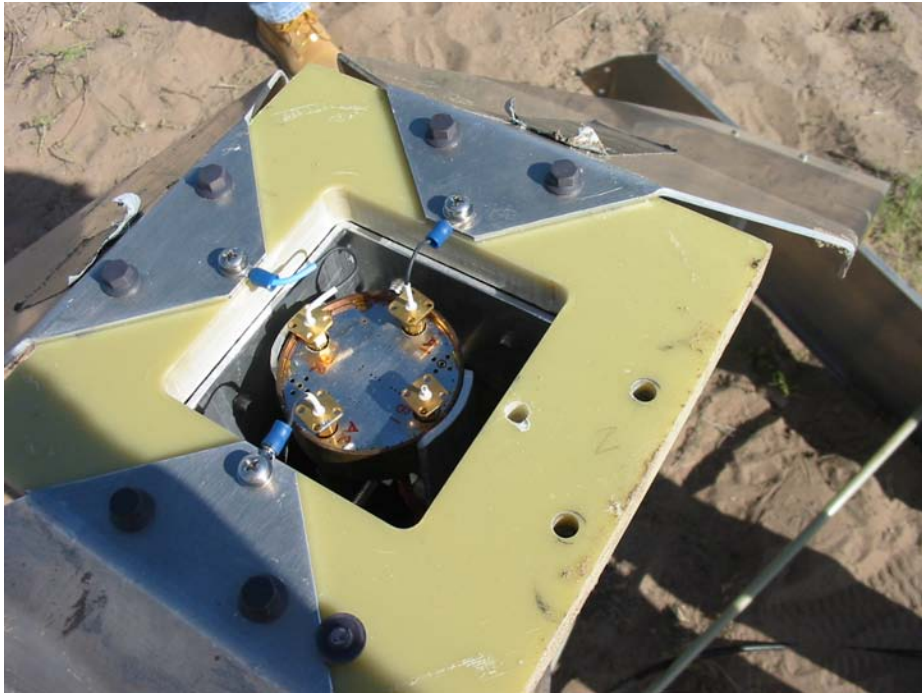
Fig. 8. The Hicks balun post antenna damage. One wire connecting one input port to the detached blade had been severed. Otherwise, the balun remained in tact.

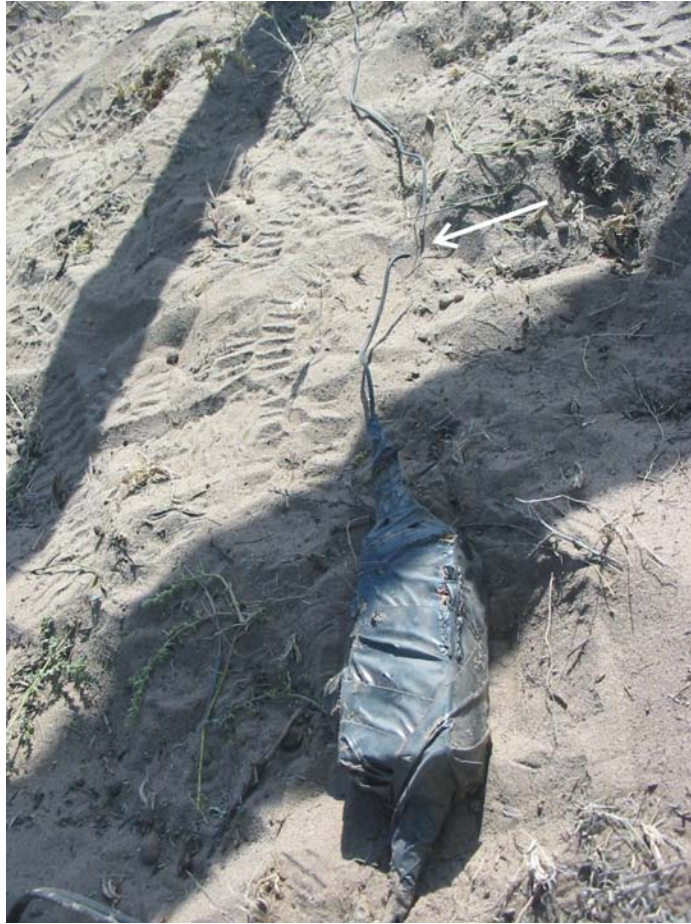
Fig. 9. The 8V power supply for the Hicks balun. The duct tape that had been wrapped in was chewed in several places, and the thin wire connecting the power supply to the balun had been chewed through completely (indicated by white arrow).

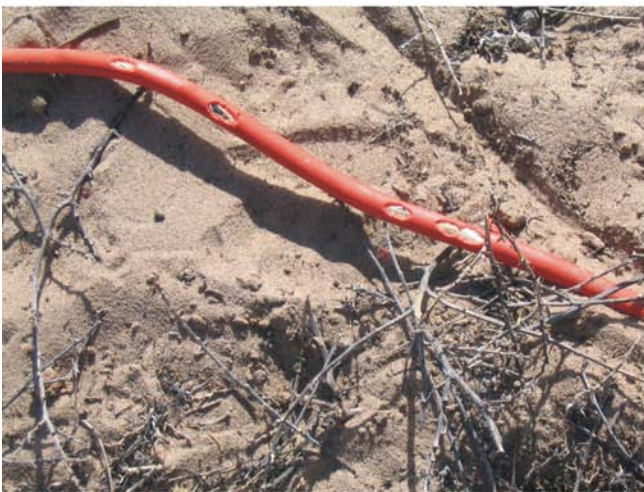
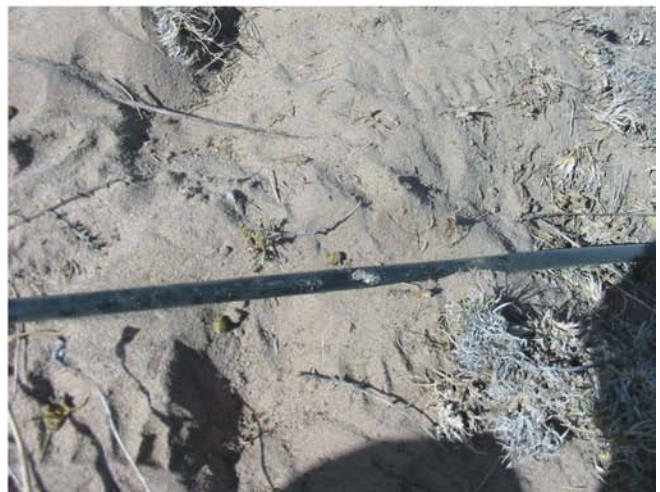
Power cable

Coaxial cable

Fig. 10. The power cable (right) and coaxial cable (left) exhibited bite marks along their full lengths. Damage was extensive enough for the copper wiring inside to be exposed in some places.

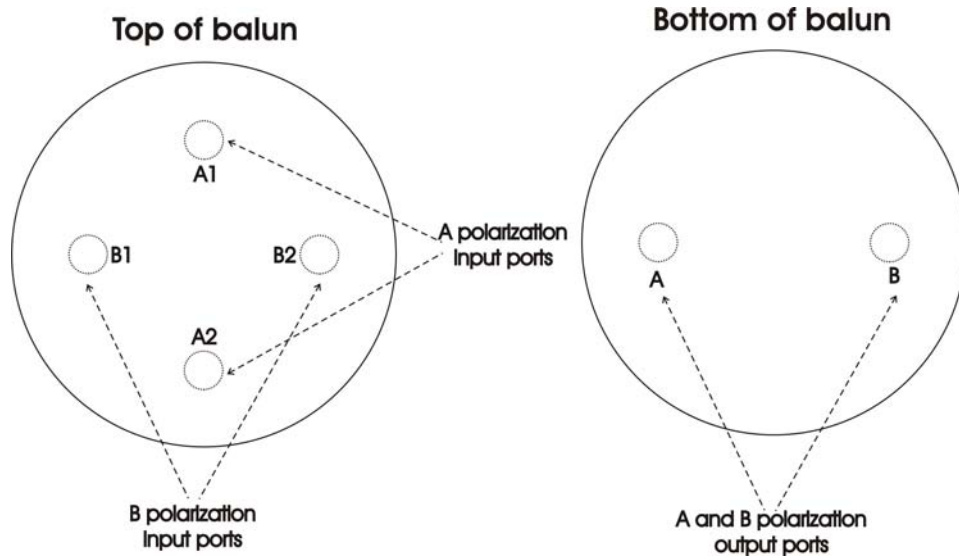
Fig. 11. A schematic of the top and bottom of the Hicks balun. Balun port designations in captions for subsequent figures in this appendix are referred back to this schematic.

This appendix contains spectra that were taken to characterize the measurement equipment. Connections to the Hicks balun are designated using the labelling system shown in figure 11. All data sets were taken from 40 – 90 MHz with a 30 kHz resolution bandwidth. All spectra were averaged over 10 traces. Since measurement results for balun polarizations A and B were similar, results for polarization A are shown here.

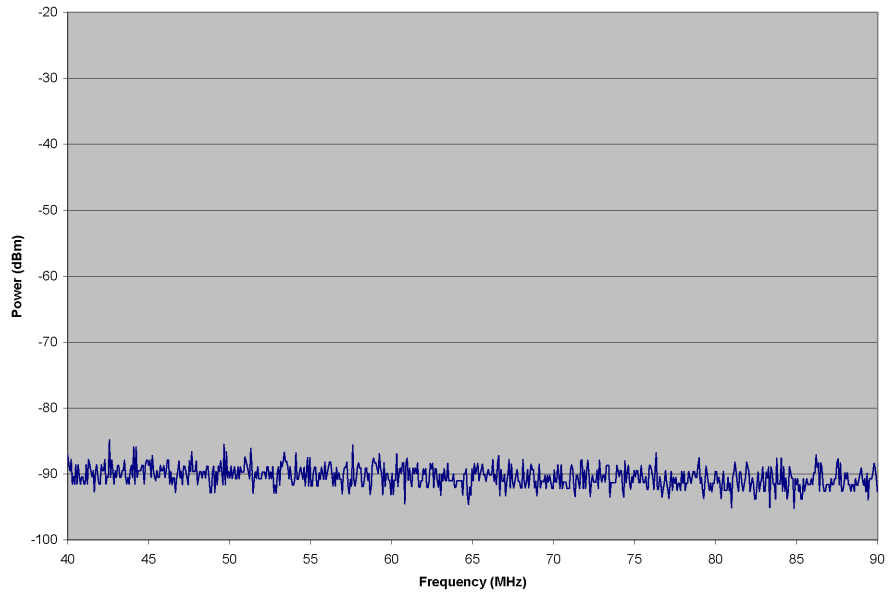
Fig. 12. The noise floor of the spectrum analyzer.

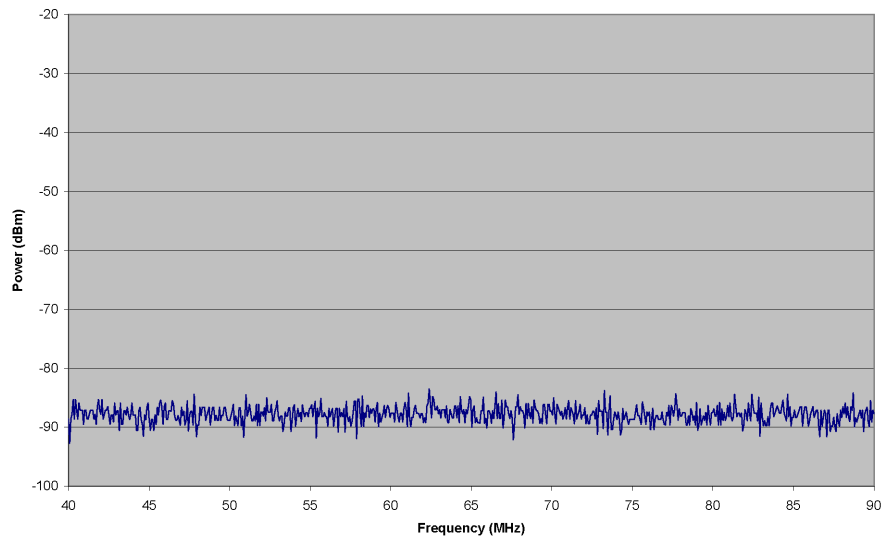
Fig. 13. Spectrum analyzer + 30 dB 2^{nd} stage amplifier (input terminated with a 50Ω termination). Although the gain of the 2^{nd} stage amplifier was 30 dB, its noise figure was so much lower than the spectrum analyzer that the noise floor in this spectrum is only a few dB above the noise floor in figure 12.

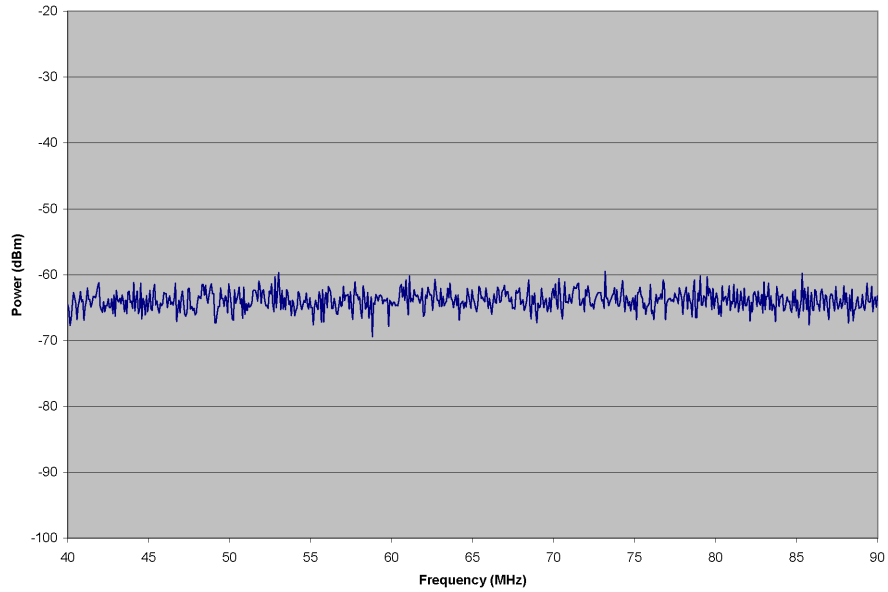
Fig. 14. Spectrum analyzer + 30 dB 2^{nd} stage amplifier + noise source with 10 dB attenuator.

Fig. 16. The average gain of the Hicks balun was ~ 22 dB over the 40 – 90 MHz frequency range. These values were obtained by taking the average difference in the noise floors between figures 15 and 14.

Fig. 18. Average loss in the 100 m coaxial cable. These values were obtained by taking the average differences in the noise floors between figures 14 and 17. LMR-400 coaxial cable was used in these measurements, and is specified to have an average loss of 3dB/100m, which is consistent with the results shown here.

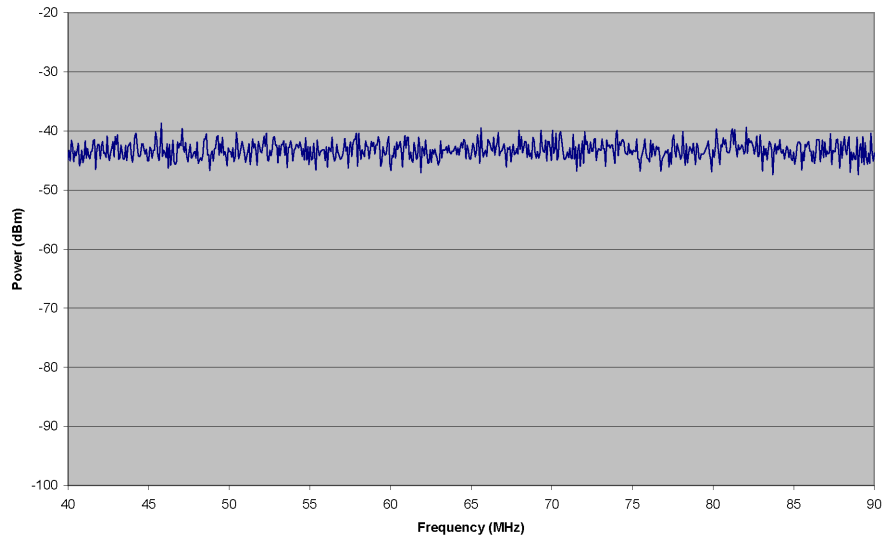
Fig. 15. Spectrum analyzer + 30 dB 2^{nd} stage amplifier connected to balun output port A + noise source with 10 dB attenuator connected to balun input port A1 + 50Ω terminations on balun input ports A2, B1, B2, and output port B.

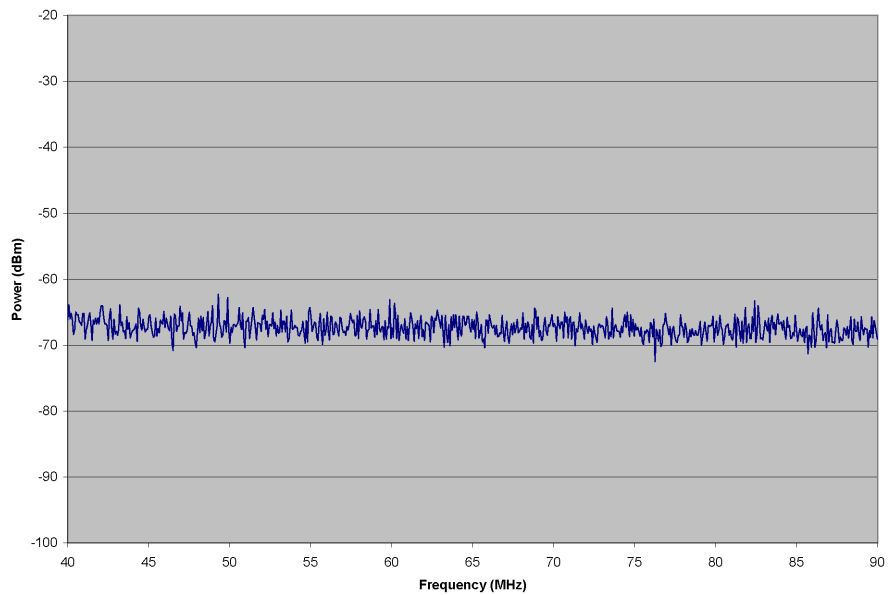
Fig. 17. Spectrum analyzer + 30 dB 2^{nd} stage amplifier + 100 m coaxial cable + noise source with 10 dB attenuator.

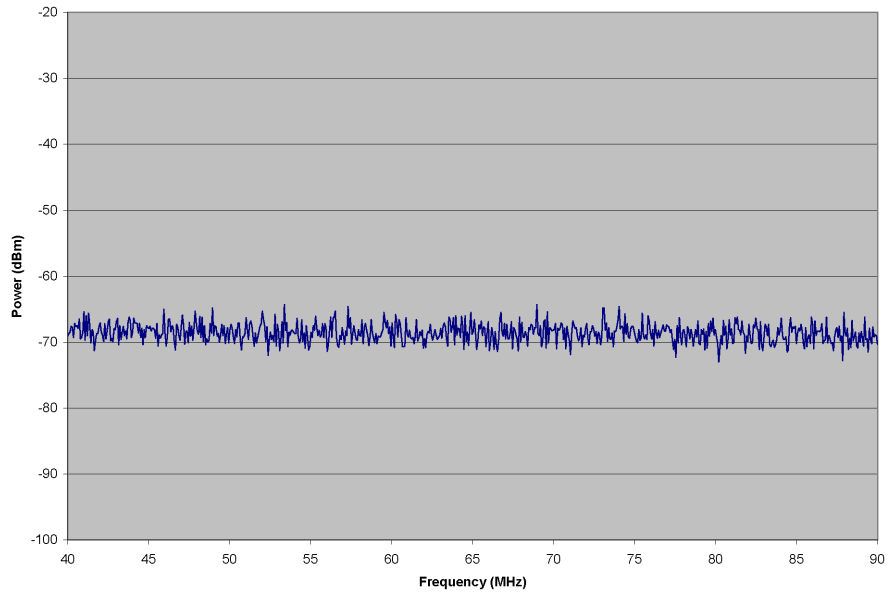
Fig. 19. Spectrum analyzer + 30 dB 2^{nd} stage amplifier + 100 m coaxial cable connected to balun output port A + 50Ω terminations on balun input ports A1, A2, B1, B2, and output port B.

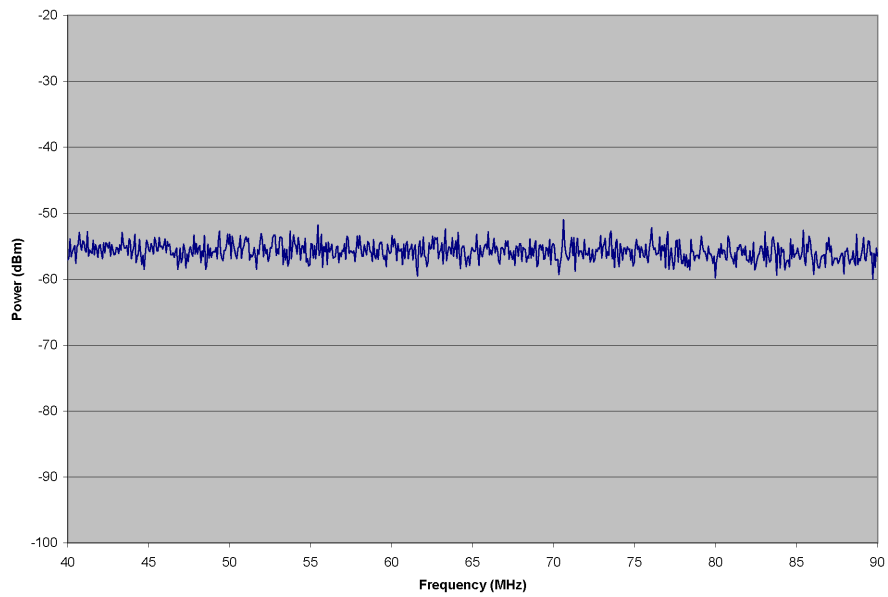
Fig. 20. Spectrum analyzer + 30 dB 2^{nd} stage amplifier + 100 m coaxial cable connected to balun output port A + noise source with 20 dB attenuation on balun input port A1 + 50Ω terminations on input ports A2, B1 and B2, and output port B.

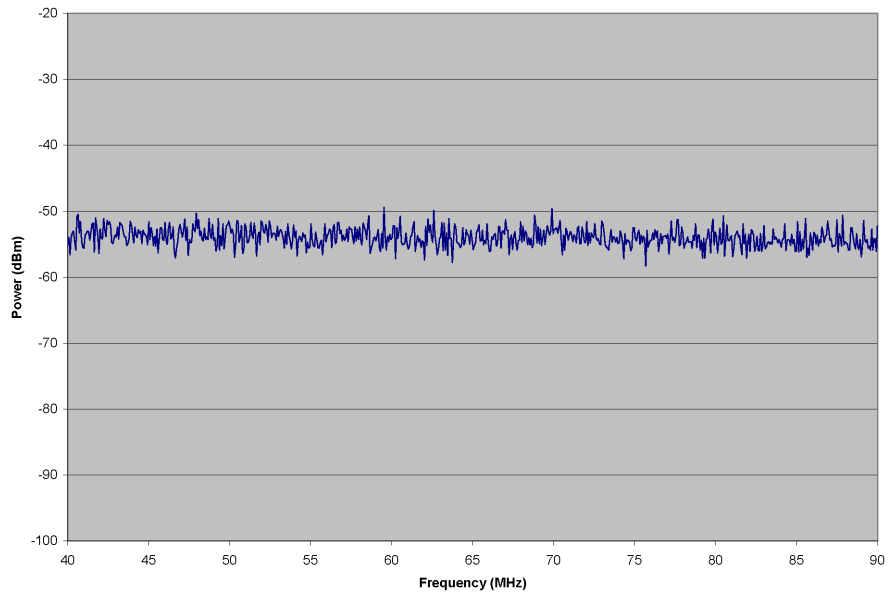
Fig. 21. Spectrum analyzer + 30 dB 2^{nd} stage amplifier + 100 m coaxial cable connected to balun output port A + noise source with 20 dB attenuation connected to the balun inputs A1 and A2 through a 3dB power splitter + 50Ω terminations on balun input ports B1 and B2 and balun output port B.

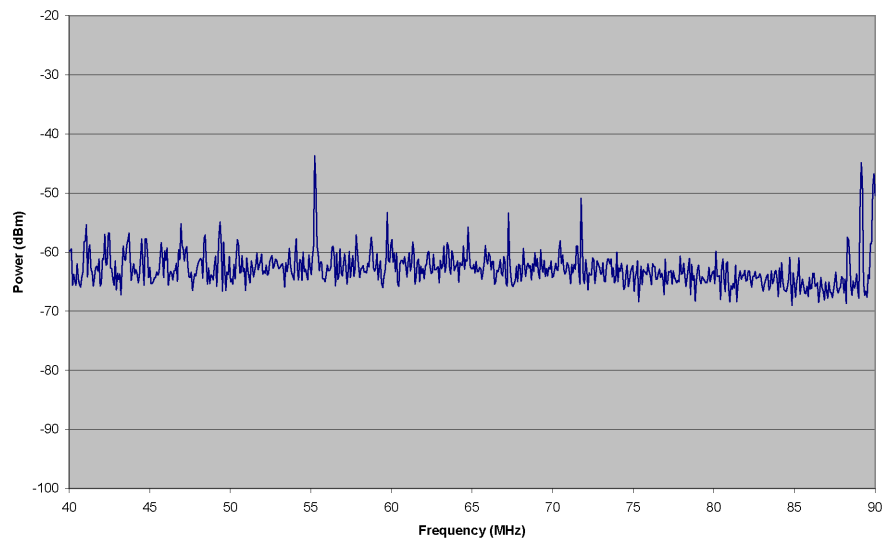
Fig. 22. Spectrum analyzer + 30 dB 2^{nd} stage amplifier + 100 m coaxial cable connected to balun output port A + balun input ports A1, A2, B1 and B2 connected to blade antenna. + 50Ω termination on balun output port B.
