Report on Installation Activities at the LWDA Site

John Copeland, Aaron Kerkhoff, Charlie Slack, Johnathan York

This brief report offers a summary of the Long Wavelength Demonstrator Array (LWDA) installation activities that occurred during the week of June 19-23, 2006. We will focus on briefly identifying what was accomplished, what remains to be done, and then some interesting points to guide future efforts at the site.

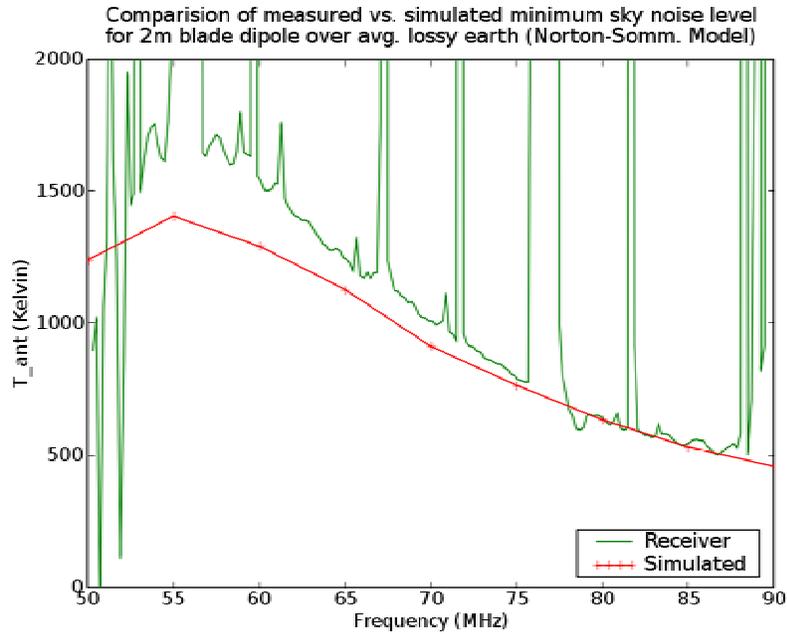
Figure 11. Measured and simulated sky noise results. The measured values were taken at the LWDA site with the LWDA receive chain.

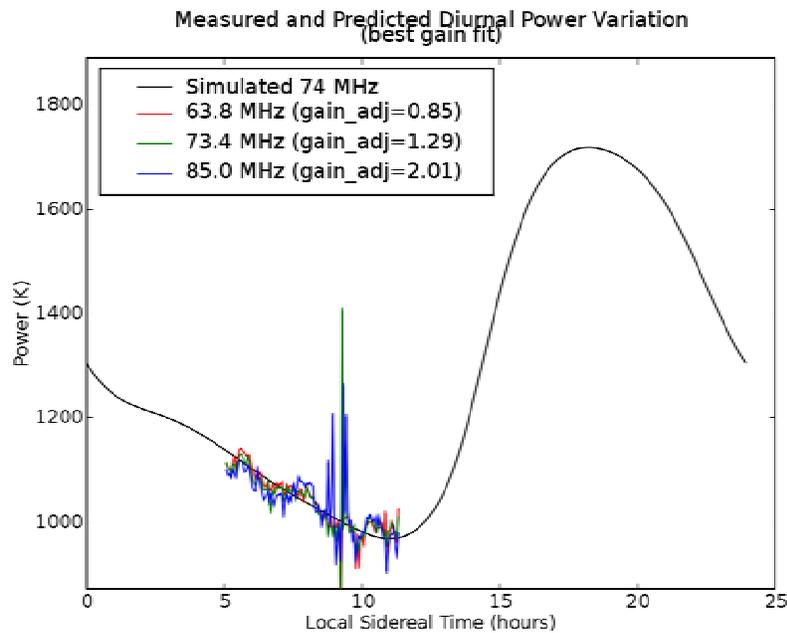
Figure 12. Measured sky noise in quiet bands as a function of time. A frequency-dependent gain adjustment (of 29% at 73.4 MHz) has been applied to the measured results. No attempt was made to eliminate RFI from the raw data.
